Manhole Inspection Summary

Manhole # S65G__010MH

Insp Date: **3/17/08 11:25 AM**

Location Address: **337 Cornwall St.**

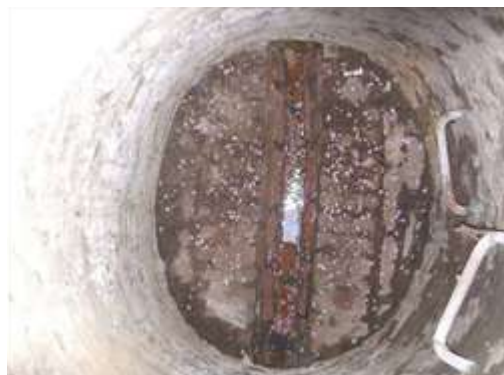
Top View

Comments **NEED BETTER QUALITY TOPSIDE PIC. TOO DARK**

O12 top of picture

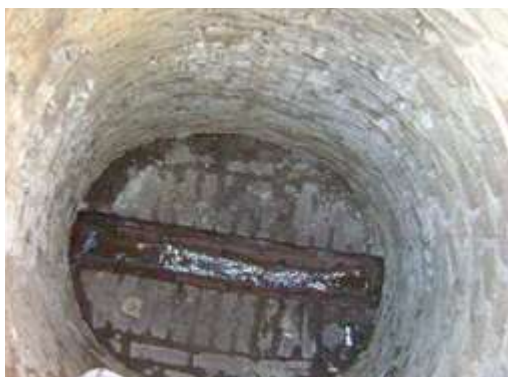
Defect 2

Infiltration through bench

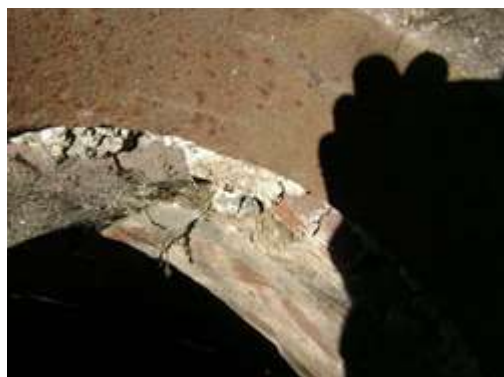
Defect 1

Condition: ☐ Sound ☐ Cracked ☐ Root Intrusion ☒ **Loose Brick** ☒ **Deteriorated**

Infiltration: ☐ None ☒ **Joint** ☐ Cracks ☒ **Mortar** ☐ Roots ☐ Wall

Loose/missing bricks in chimmney

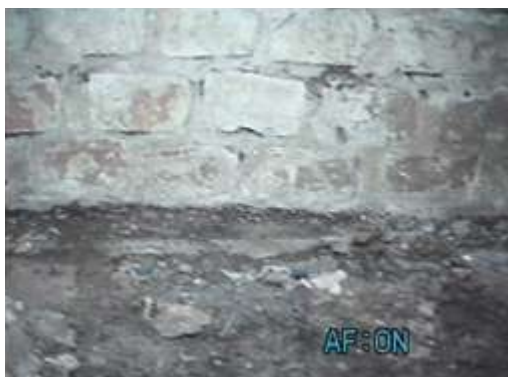
Defect 4

Bench infiltration

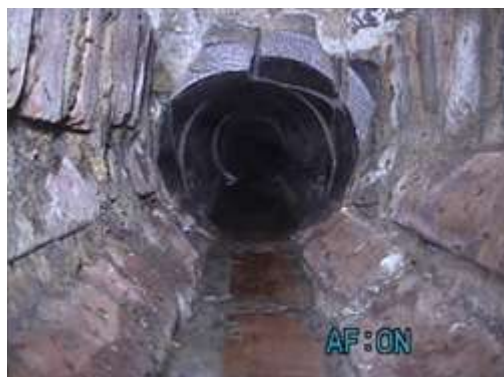
Defect 3

Fractured outgoing 12 O'Clock pipe @ 12:00 to 1:00

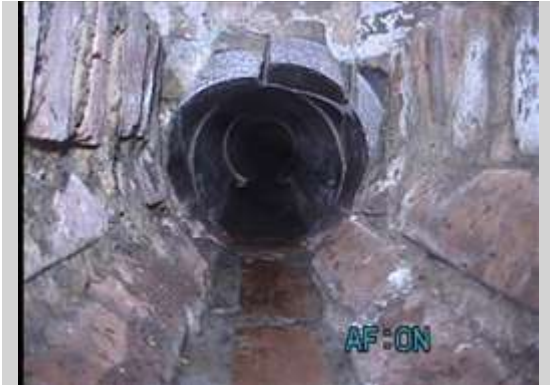
12 O'Clock Outflow

Pipe Height: **8.4** (in.) Rod and Bar (Angled)
Pipe Material: **Clay** ☐ Pipe Lined
Invert Depth: **7.50** (ft.) Flow Characteristics: **Slow**
Deposits: ☒ None ☐ Mud ☐ Sludge ☐ Debris ☐ Grease
Silt Depth: (in.) Deposits Extent:
Infiltration: **None** Pipe Seal Cond: **Cracked**

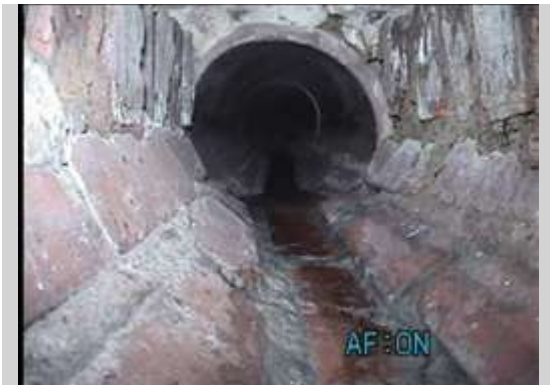
6 O'Clock Inflow

Pipe Height: **8.4** (in.) Rod and Bar (Angled)
Pipe Material: **Clay** ☐ Pipe Lined
Invert Depth: **7.46** (ft.) Flow Characteristics: **Slow**
Deposits: ☒ None ☐ Mud ☐ Sludge ☐ Debris ☐ Grease
Silt Depth: (in.) Deposits Extent:
Infiltration: **None** Pipe Seal Cond: **Sound**
